**UNDERWATER FACILITIES  
INSPECTION AND ASSESSMENT  
AT**

**MAGNETIC SILENCING FACILITIES  
NAVAL STATION  
CHARLESTON, SOUTH CAROLINA**

**FPO-1-84(39)**

**NOVEMBER 1984**

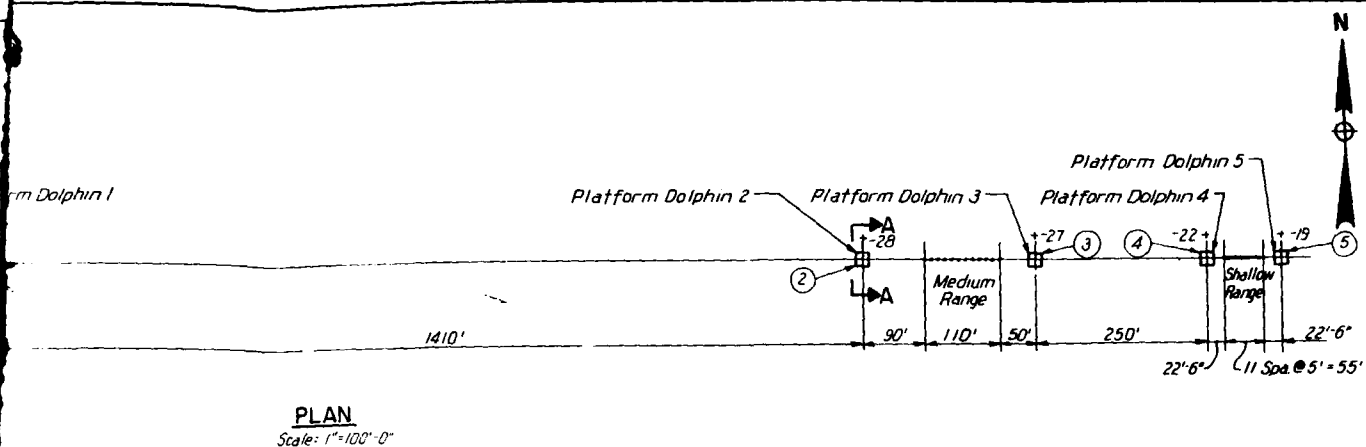
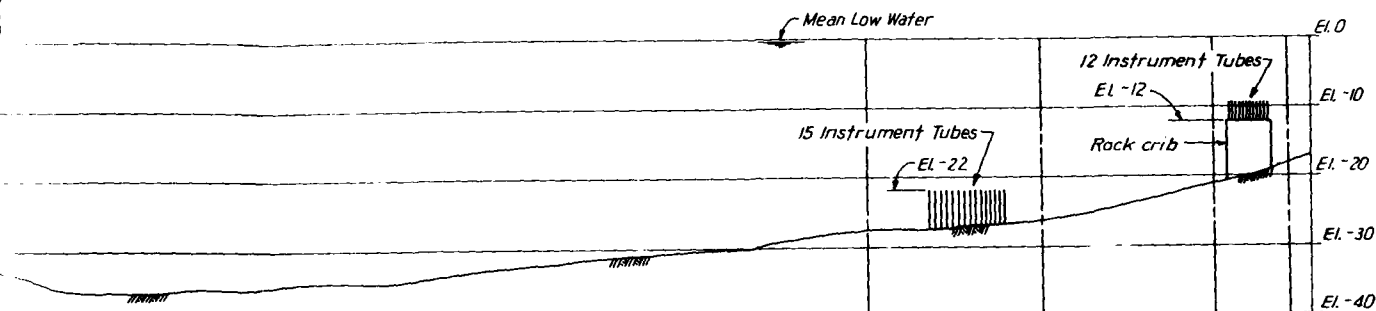
1. 10%-30% loss of section 4 piles for 2ft. at M.L.W.
2. 10%± loss of section of 4 piles for 2ft. at M.L.W.
3. 20%± loss of section of 4 piles for 2ft. at M.L.W.
4. 10%-25% loss of end of horizontal bracing for 1ft. at ends.
5. 10%± loss of section of piles for 2ft. at M.L.W.
6. 3 horizontal braces missing; 1 brace poor condition.
7. 10%± loss of section of piles for 2ft. at M.L.W.
8. 1 horizontal brace missing, 3 braces with 25%± loss of 1ft. at ends.
9. East face of cap cracked; bottom edge broken off.

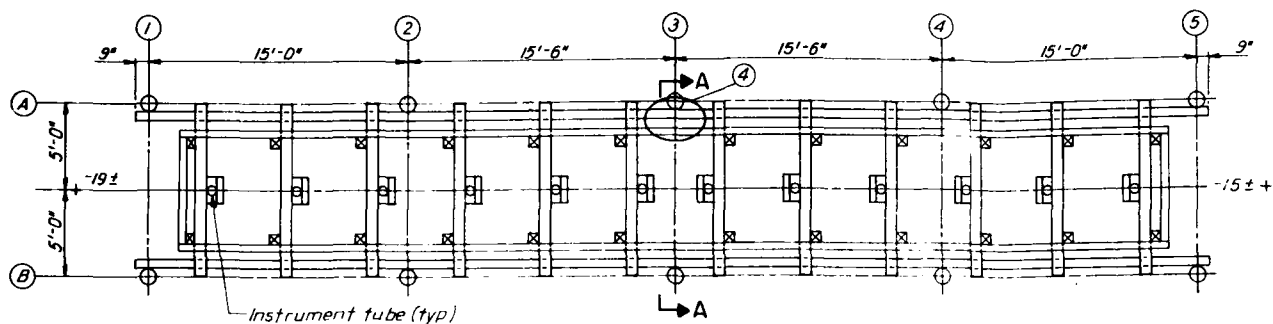
FIG. NO.  
**4.2-3**

1. All instrument tubes in good condition; vertical within  $\pm 1^\circ$ ; no tags on tubes.
2. Crib generally in good condition; minor holes in sheeting near east end of crib.
3. No undermining of crib.
4. Top timbers displaced  $6'' \pm$  at joint.
